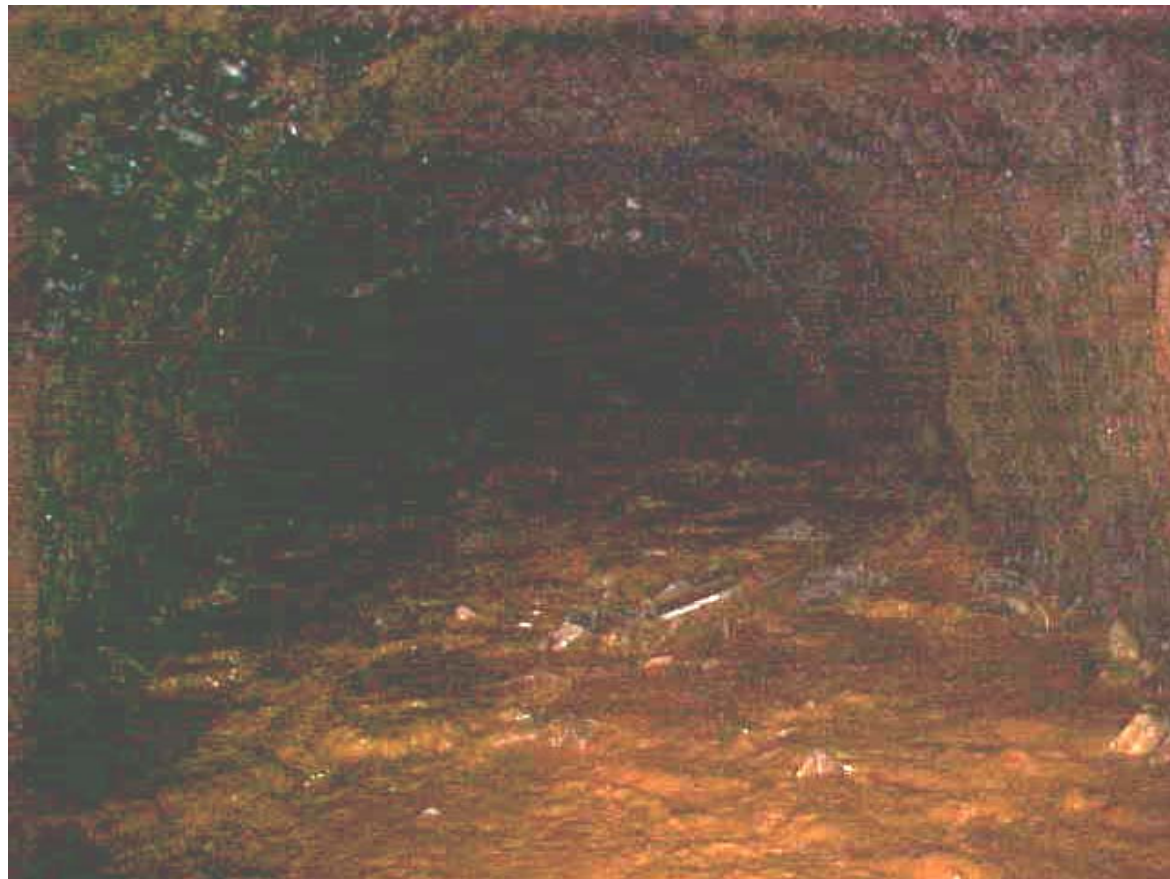
Looking upstream towards the bottom of the Barney Vent Raise on 10 Level. The bottom of the raise is about 200 feet up this drift. The debris and muck in the bottom of the drift accumulated when water drained into the raise to clean it out must have built up--then suddenly blew out carrying the debris with it. The diverted water is flowing across the top of the debris and muck. The depth of the debris increases towards the raise. At the back of this drift near the bottom of the raise the debris is up to within one to two feet of the ceiling. Removal of this debris would be very difficult. There appears to be adequate open space for water flow.
